Lower Duwamish Waterway Survey of Potential PCB-Containing Building Material Sources

Summary Report

Washington State Department of Ecology
Toxics Cleanup Program
Northwest Regional Office
Bellevue, WA

June 2011

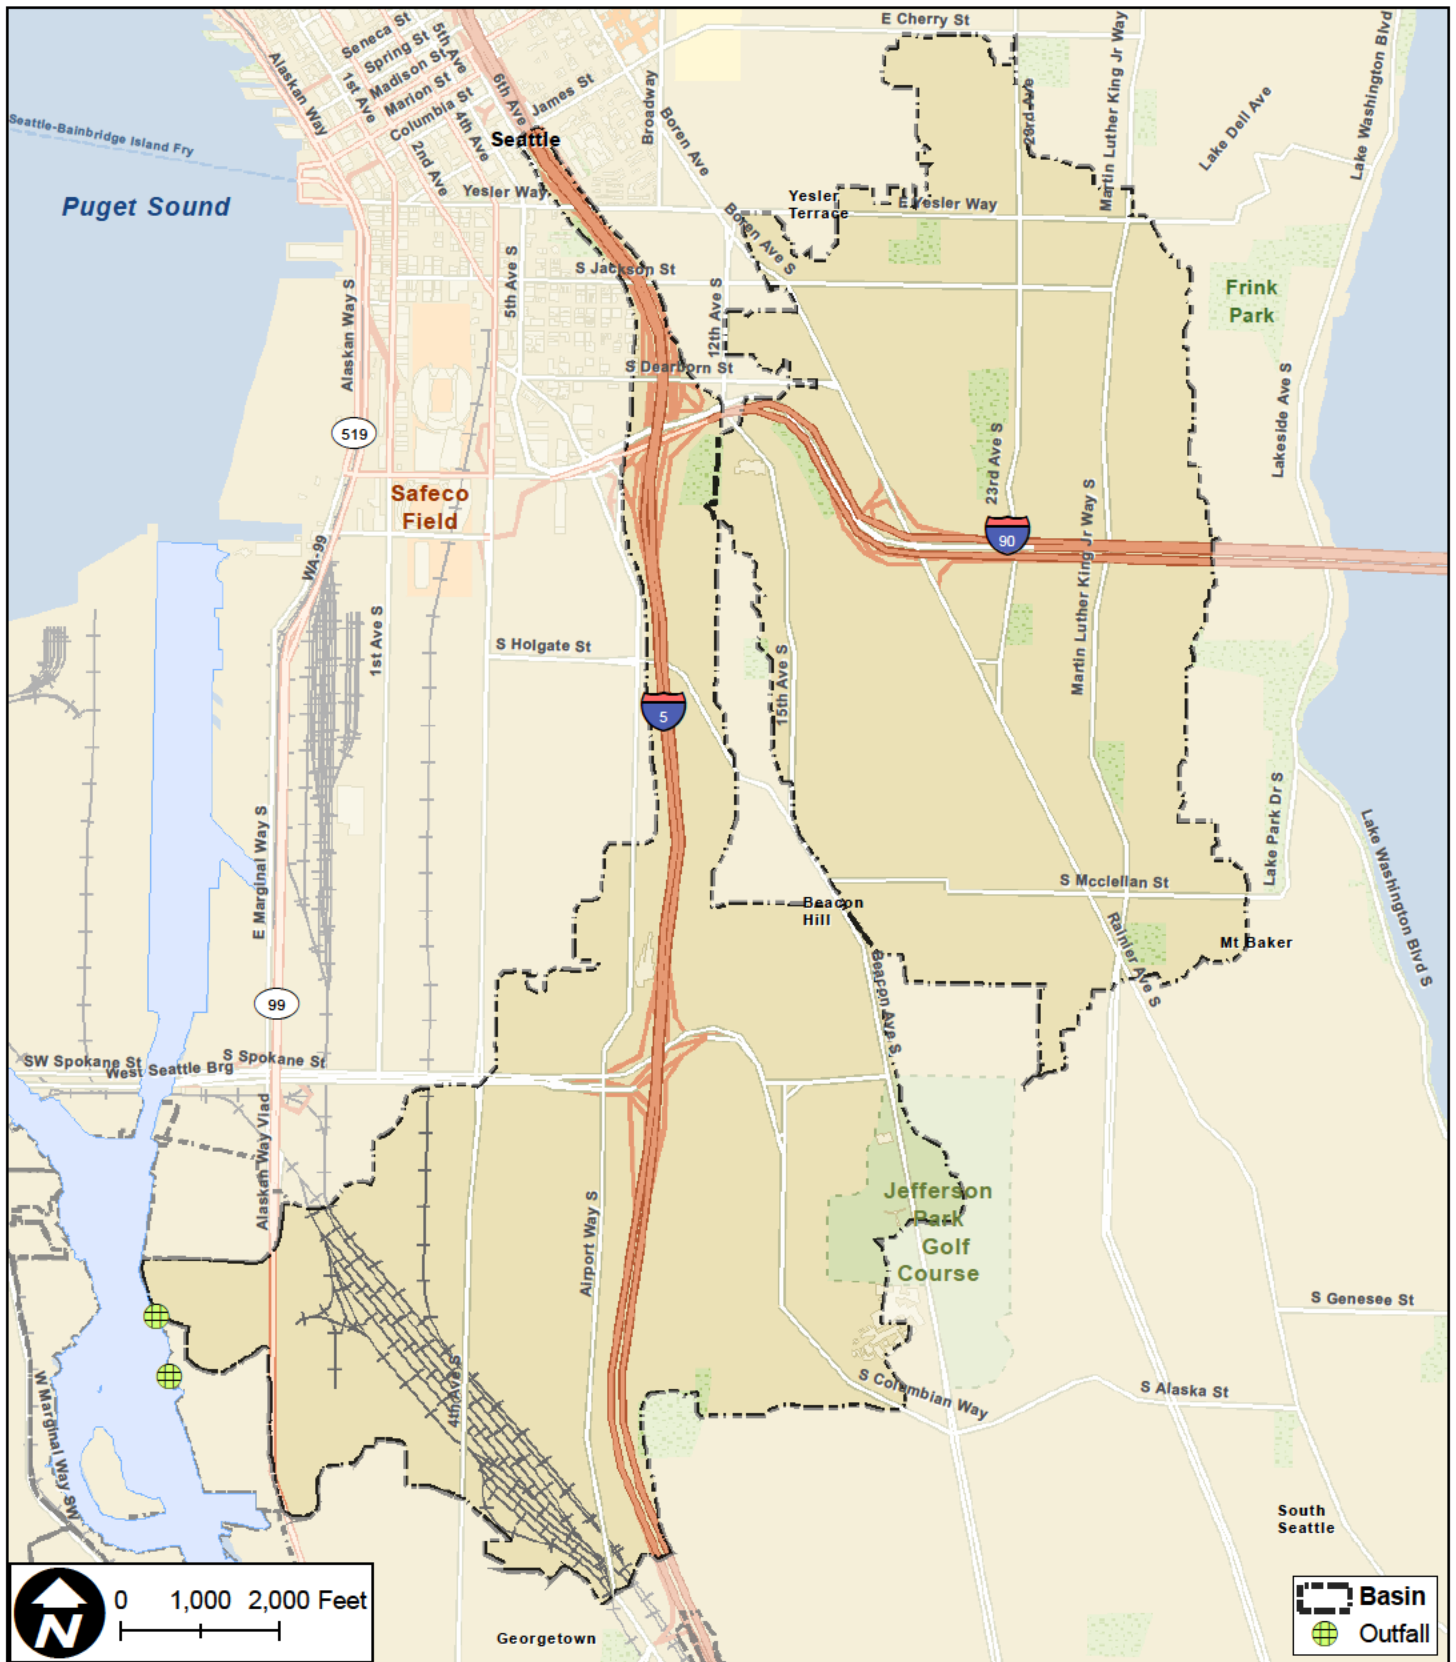
Figure 2. Diagonal Avenue S Storm Drain Basin

A visual survey of the buildings within the Diagonal Avenue S storm drain basin, shown in Figure 2, was conducted between January 31 and February 3, 2011. Buildings that were near existing storm drain solids sampling locations and that were constructed between 1950 and 1977 were preferentially selected for the survey.³

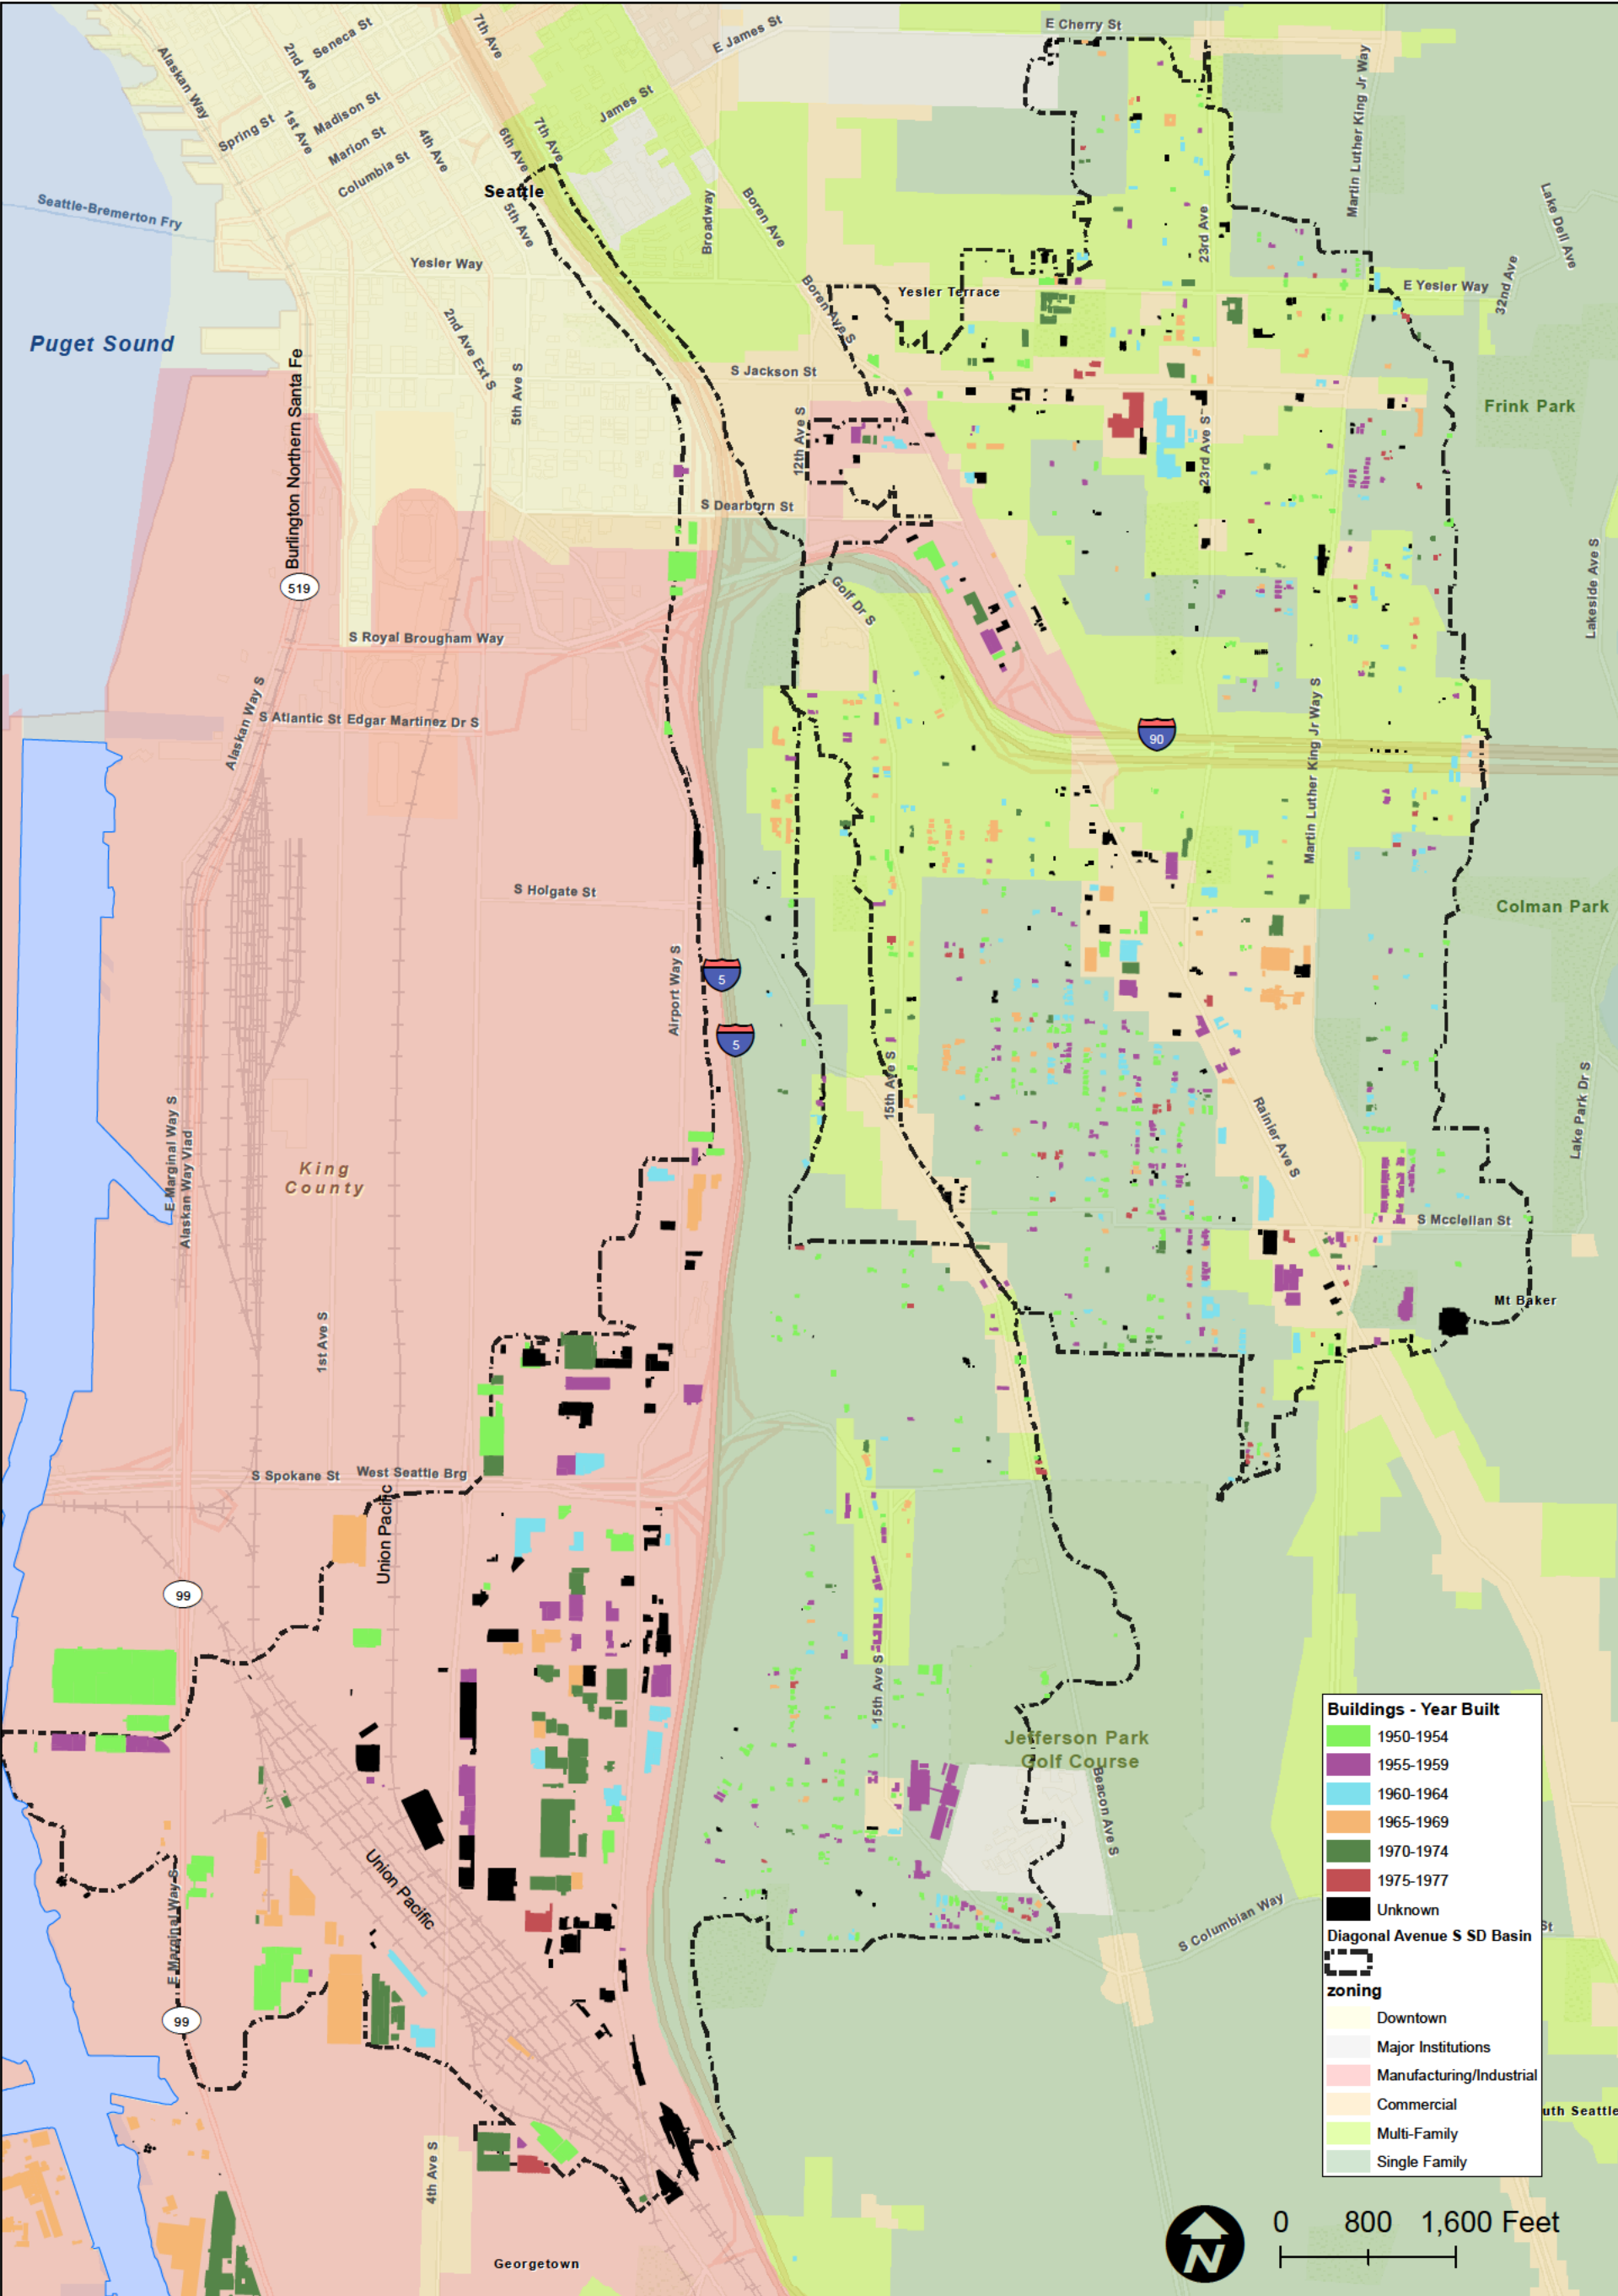
**Figure 3. Buildings Constructed Between 1950 and 1977,
Diagonal Avenue S Storm Drain Basin**

Based on King County Geographic Information System (GIS) shapefiles, the LDW separated storm drainage area was estimated to encompass approximately 9,000 acres and 27,003 buildings. According to data from the King County Recorder's Office, 7,594 of these buildings were constructed between 1950 and 1977. Upon consultation with Ecology, SAIC selected the Diagonal Avenue S stormwater drainage basin as representative of the entire LDW drainage basin. The Diagonal Avenue S storm drain basin (Figure 2) covers 2,620 acres, an area of approximately 4 miles by 1.5 miles, and contains a variety of industrial, commercial, and residential buildings. According to the County Recorder's Office data, a total of 2,286 buildings in the Diagonal Avenue S basin were constructed between 1950 and 1977; these are shown in Figure 3.
